July 28, 2000

Winston-Salem, NC Liberty Street Corridor Brownfields Pilot Study

EXECUTIVE SUMMARY

Project: Flowers ESA
Phase I

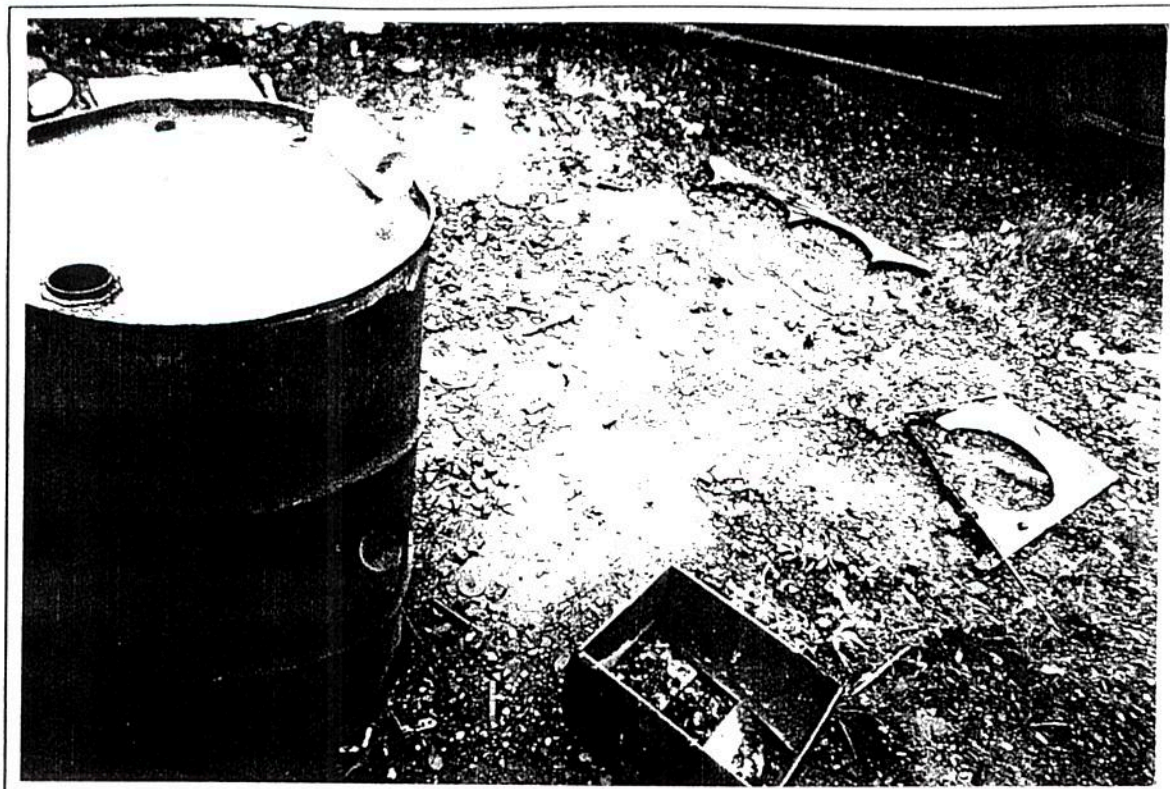
Two 55-gallon drums are present outside (in the rear of) the building as well. One of the drums was approximately one-third full of a viscous hydrocarbon substance, and is partially uncovered. Evidence of soil staining (~8'X6') was evident in this location. The second drum behind the structure was about half full, and was labeled as hydraulic oil. The drum appeared to be devoid of holes, but soil staining was evident at the base of the drum, extending approximately 10 feet downgradient from the drum. Other evidence of staining was found in the southeast corner of the fenced area. A 5' X 5' area devoid of vegetation and dark in color, was observed at the base of a pile of broken up concrete. Dead vegetation extended beneath the fence and toward the stream at the rear of the site.

7c: 55 gallon Drum (1/3 full of oily substance) and associated soil staining.

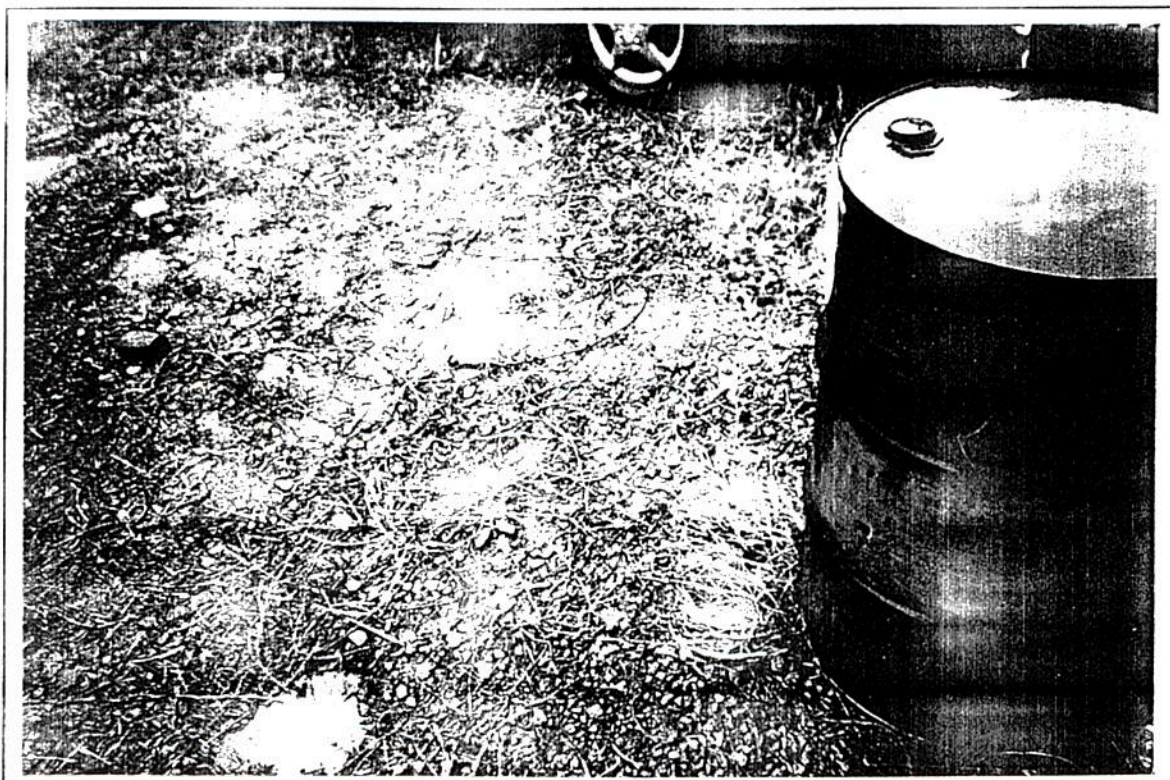
7d: Hydraulic oil drum and associated soil staining.

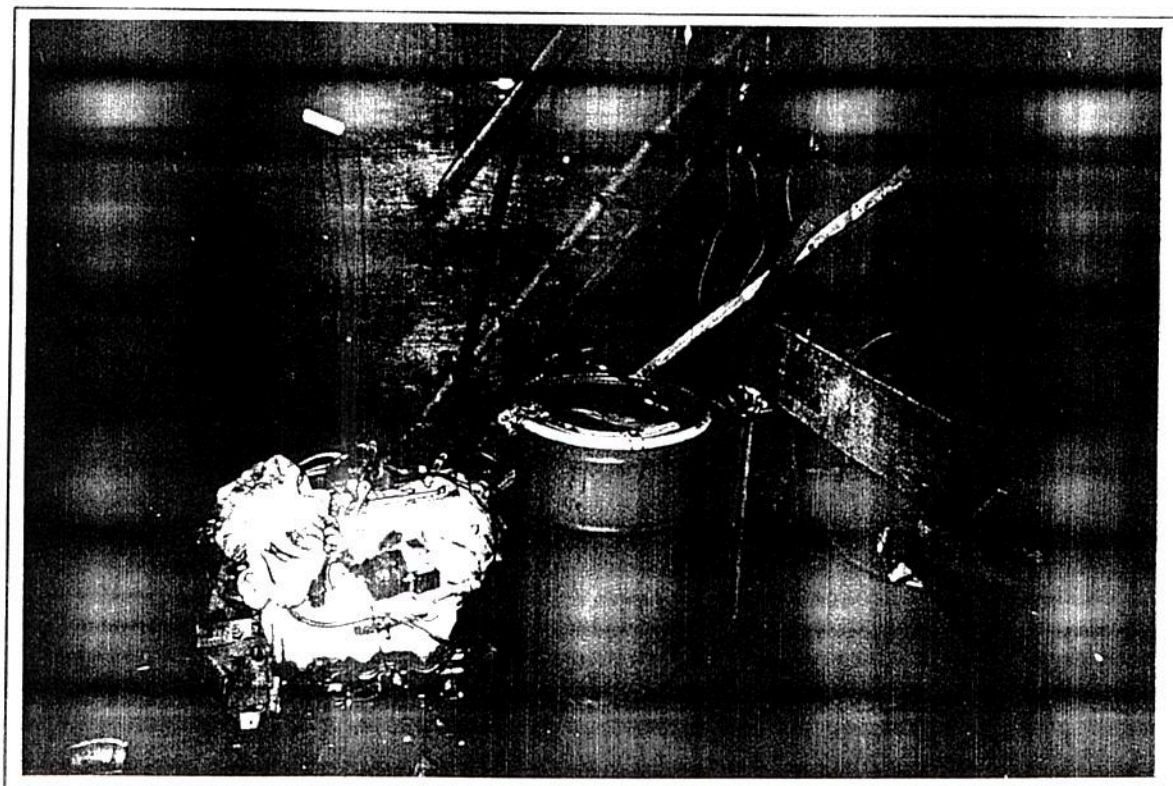
No evidence of commercial or industrial practices was noted on the subject site that would require the handling and/or storage of hazardous waste beyond the use of Safety-Kleen Gold degreaser (Naphtha), and the used oil.

7h: Safety-Kleen Premium Gold Drum.
